# SCD **Case Study**

January 2018

Patient treated by Dr Simon Killough  
BSc(Hons) BDS MFDS FDS(Rest Dent) PhD Specialist In Restorative Dentistry

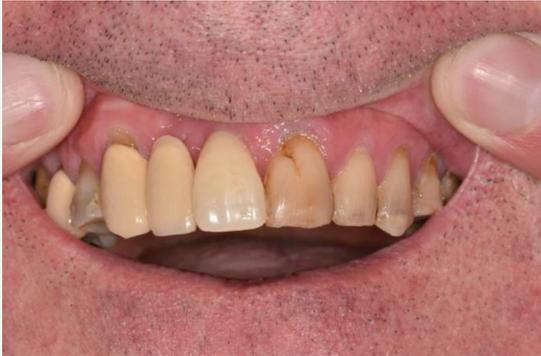
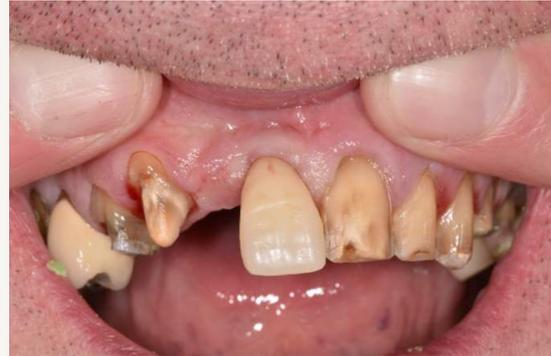
The patient presented initially with an UR1 missing, the tooth being extracted due to a failed post crown. A temporary acrylic denture was provided to allow for socket healing. When healing was complete an Ankylos implant was placed in the UR 1. A PFM bridge was already in place UR 3-2. There was an aesthetic discrepancy between the crown and bridgework on the UR 3-2-1 and the natural teeth UL 1-2-3. The patient requested an improvement in the appearance of the upper anterior teeth.

Preoperative presentation of the patient

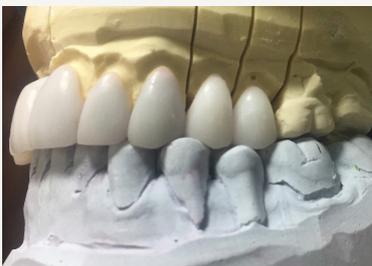
Preoperative diagnostic wax up

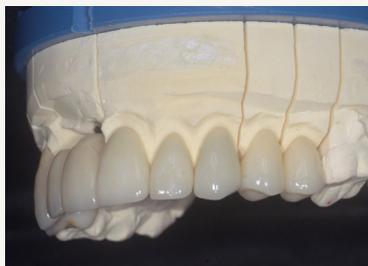
Restoration side view

1. IPS e.max® crowns on the UR 4, UL 4-5 with the IPS e.max® veneers on the UL 1-2-3.
2. A conventional cantilever bridge, fabricated in Porcelain Fused to Zirconia (PFZ), with the retainer on the UR 3 and a pontic on the UR 2.
3. UR1 anodised titanium ANKYLOS® abutment with an IPS e.max® implant crown (modified screw retained).

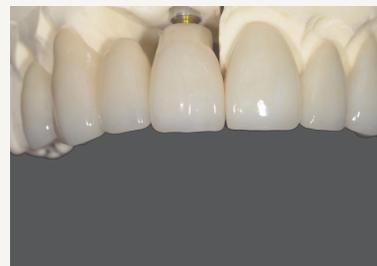
Restoration anterior view

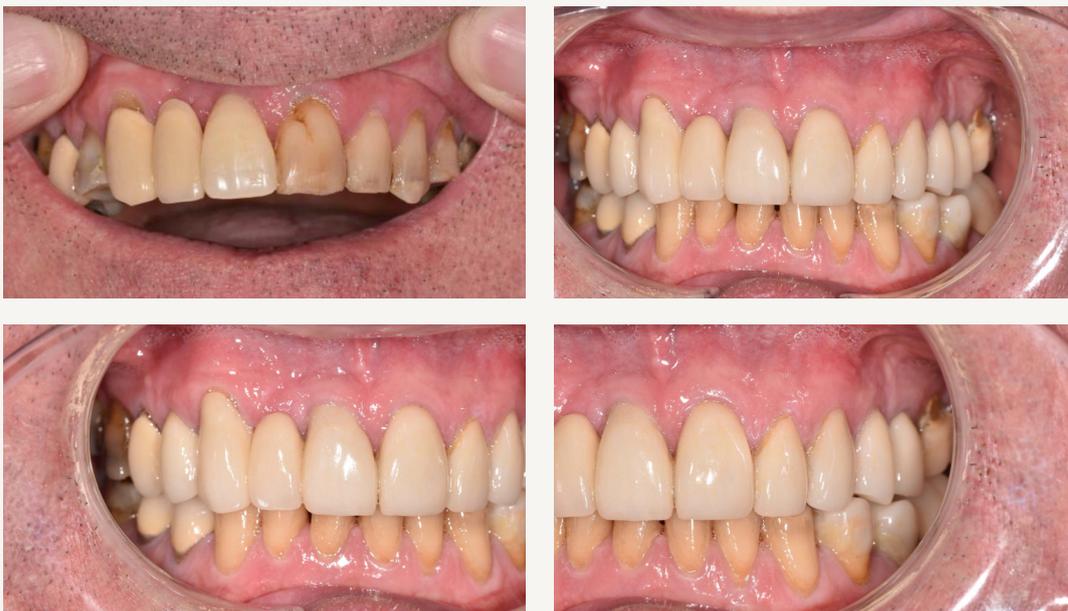
Preoperative and post-operative comparison
