Challenging aspects of implant restoration

Brenda Baker and **David Reaney** explain various methods to restore function and aesthetics to patients in need of implant restoration

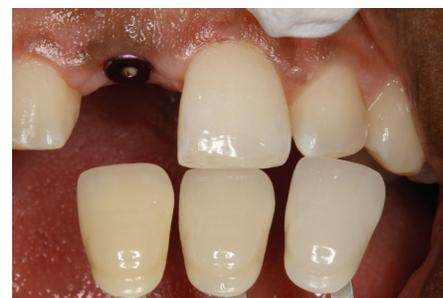
Figure 1: Anterior tooth aesthetics are critical. Colour data with shade tabs against various teeth will help guide the laboratory

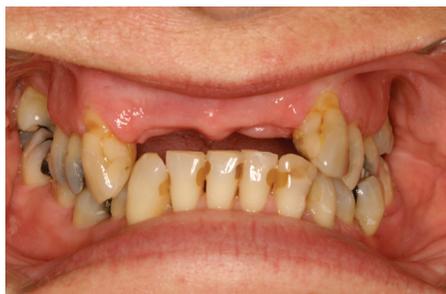
Figure 2: Minimal space is evident anteriorly for aesthetic functional reconstruction

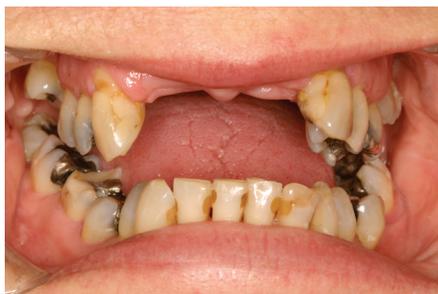
Figure 3: The irregularity of the occlusal plane is clearly illustrated when the patient's mouth is partially open

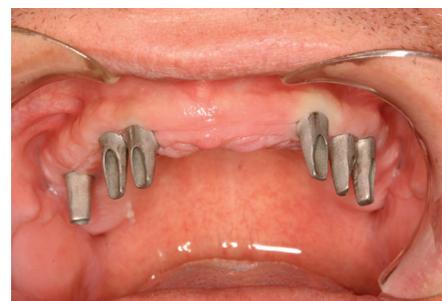
Figure 4: These implants show excellent tissue health around the abutments
