Case Study

Treatment Considerations for Implant Rehabilitation

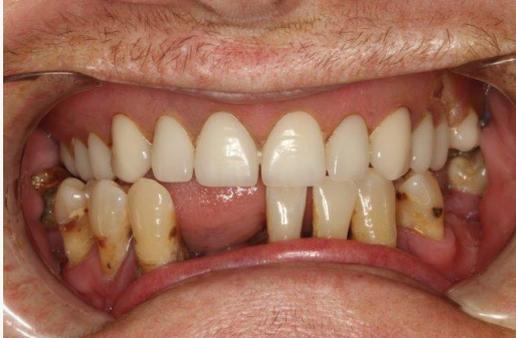
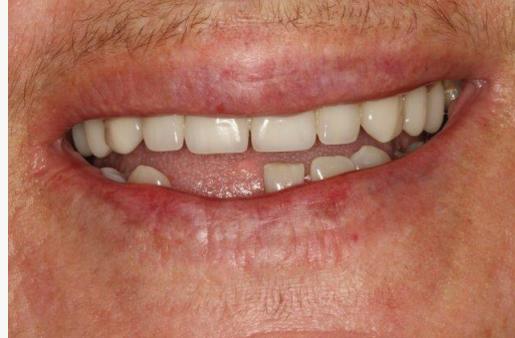
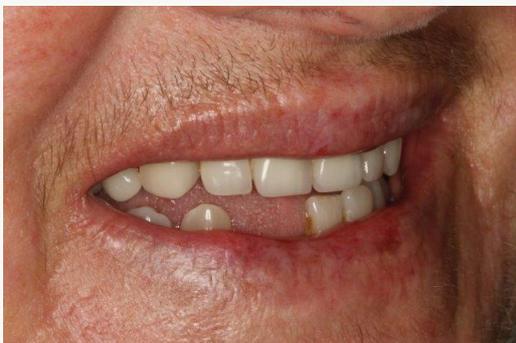
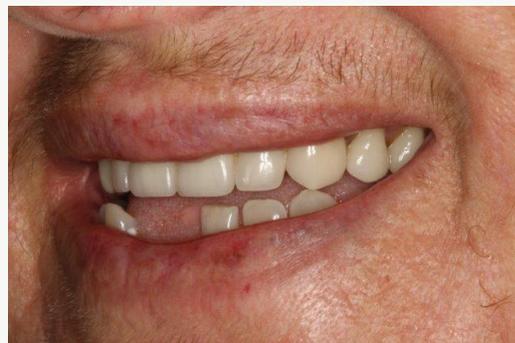
The presenting condition is viewed in FIG. 1a, b, c and d.

FIG. 1a Frontal view

FIG. 1b Frontal view-smile

FIG. 1c Right lateral

FIG. 1d Left lateral

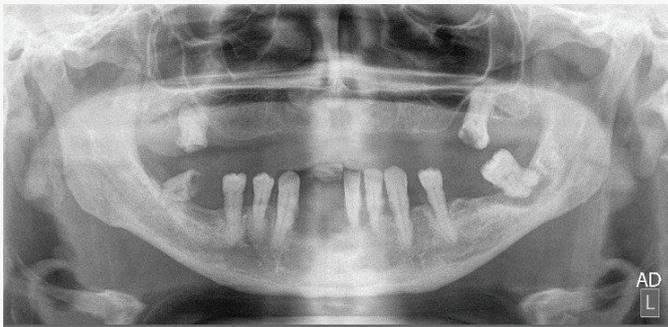
FIG. 2

The initial panoramic radiographic revealed irreversible destructive periodontitis. A significant periapical lesion was noted on the lower left mandibular molar (FIG. 2).

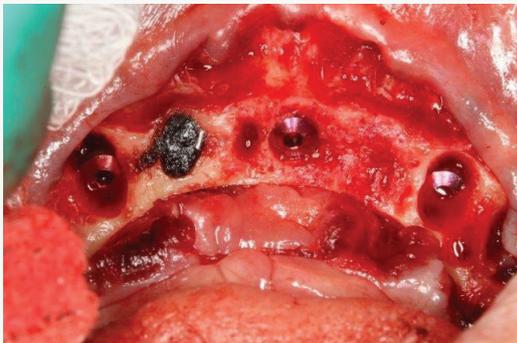
FIG. 3a Implant placement

- LA Used: Articaine 4% 1:100000 Adrenalin 10.8 mls inferior dental block Quadrant 3 Quadrant 4
- Buccal flap raised Performed osteotomy to insert implant
- 35: MIS 3.75 x 8mm Seven internal hex LOT:WO2196421 Torque 50Ncm
- 45: MIS 3.75 x 8mm Seven internal hex LOT:W13000918 Torque 50Ncm
- Coverscrew placed
- Sutured using Chromic Gut 5/0

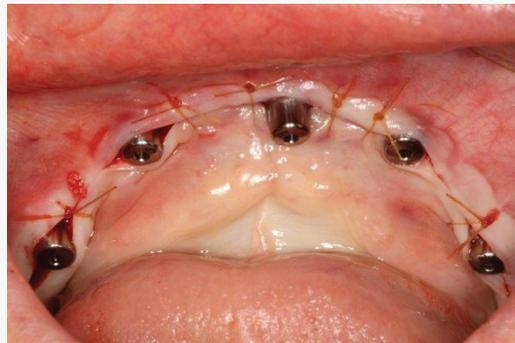
FIG. 3b Occlusal view of edentulous mandible with healing abutments in place.

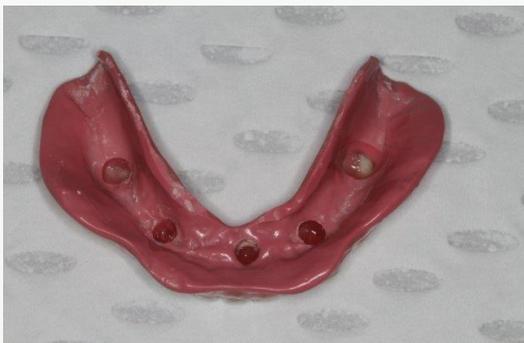
FIG. 3c The existing mandibular denture was relieved, relined and repolished.

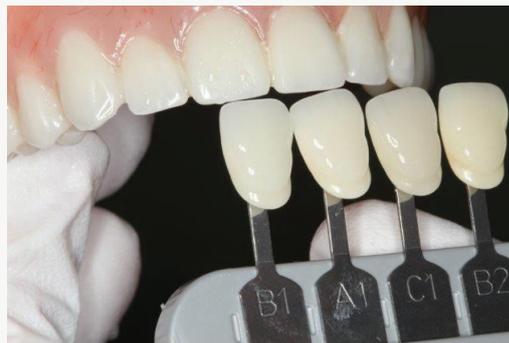
FIG. 3d Shade selection with existing denture

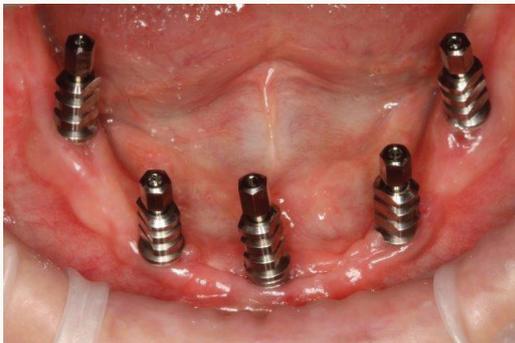
FIG. 4a Pick-up impression coping in place

- Removed healing abutments and placed MIS pick up impression copings into 45, 43, 31, 33, 35
- Lower impression using Affinis® (COLTENE) heavy and light body PVS
- Replaced healing caps
- Took upper alginate for special tray and bite block for new Full Upper Denture
- A combination approach of both screw and cement-retained restorations both in the intermediate prosthesis and the final porcelain-fused-to-metal final restorations was employed
- Fixed provisionalisation was deemed necessary to ascertain functional, aesthetic and phonetic performance

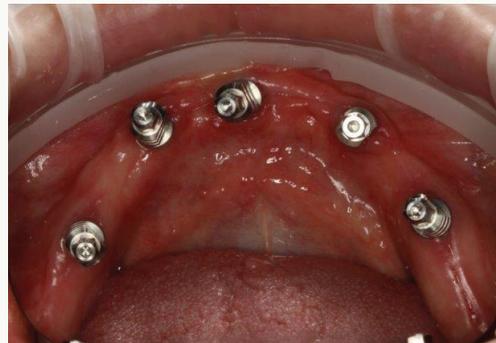
FIG. 4b Occlusal view of impression copings

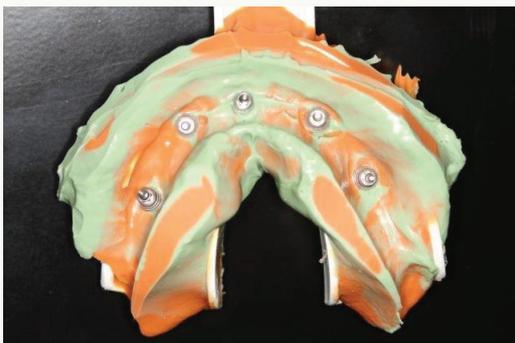
FIG. 4c Open-tray impression technique for the fabrication of the restorations.

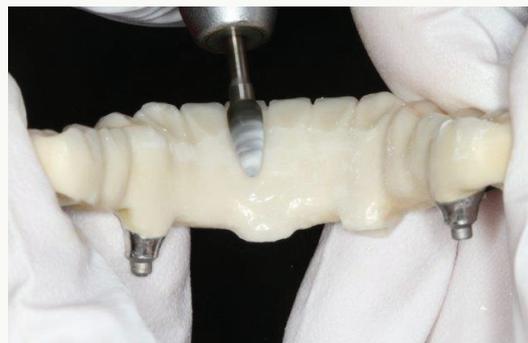
FIG. 4d Laboratory made provisionals

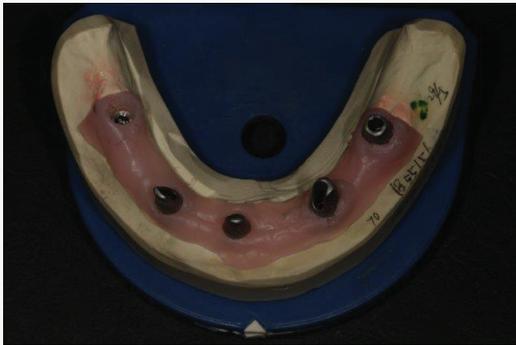
Visit 3 Fabrication of abutments (FIG. 5)

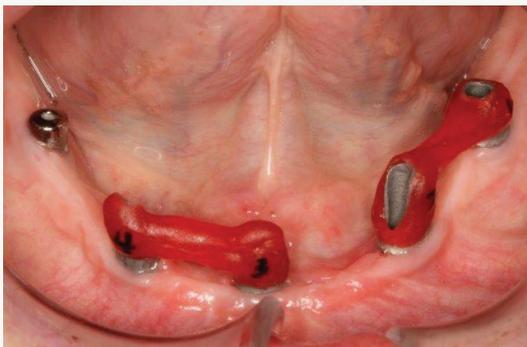
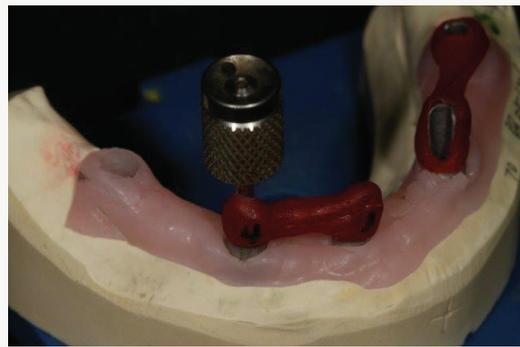
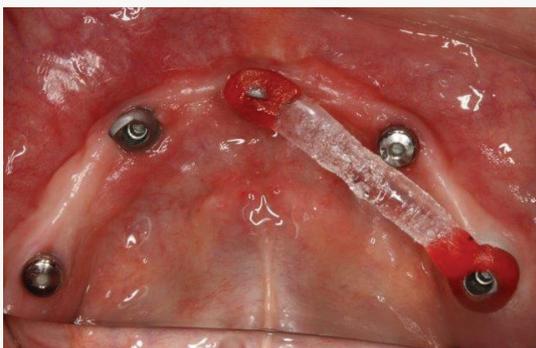
Visit 4 Try-in of abutments and verification index (FIG. 6a-6c)

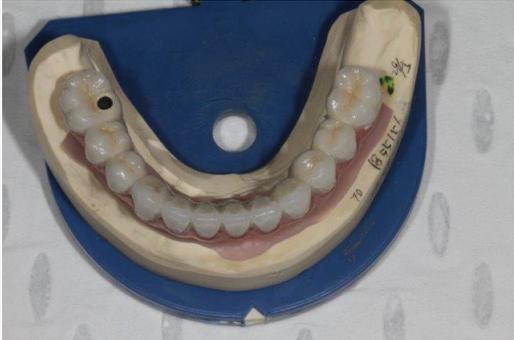
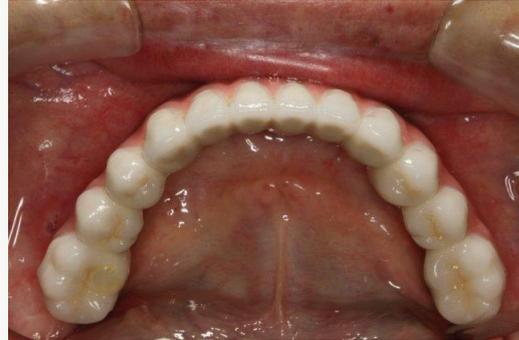
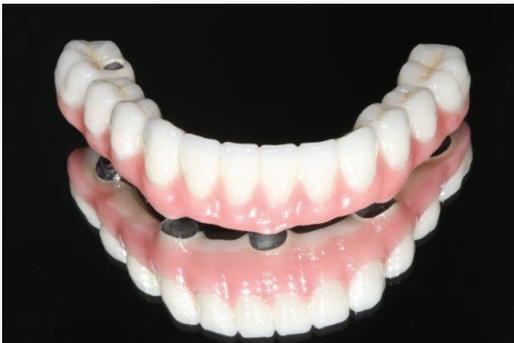
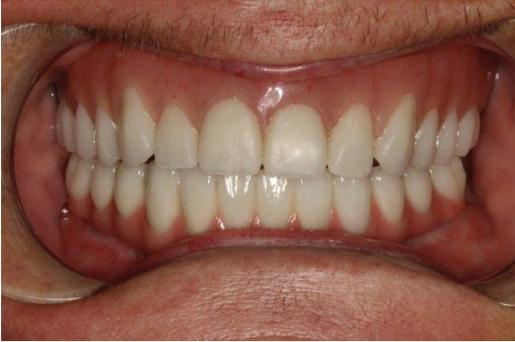
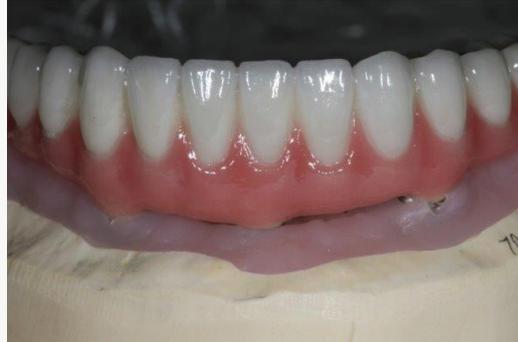
Visit 5 Try-in and final issue (FIG. 7a-7c, 8a-8b)

- The implant bridge was inserted and checked, and the patient and dentist were happy with shape, shade and fit. The prosthesis was issued on the same day and screwed in on the right hand side to 32Ncm
- The bridge was cemented onto the abutments using Freegenol™ NE (GC America)
- The access hole was sealed with silicone tape, ceramic etch, metal primer, Calibra™ silane, Clearfil™ SE bond, bellglass opaque, A1 flowable and P-A1 G-ænial composite (GC Europe)
- Temporary cement was used on the abutments to achieve a passive fit and a screw-retained restoration was included in the prosthesis so that it did not fall out
- The occlusion was checked and adjusted, and then polished
