Challenging aspects of implant restoration

David Reaney and **Brenda Baker** show how careful planning and a methodical approach can restore function and aesthetics to a patient in need of implant restoration

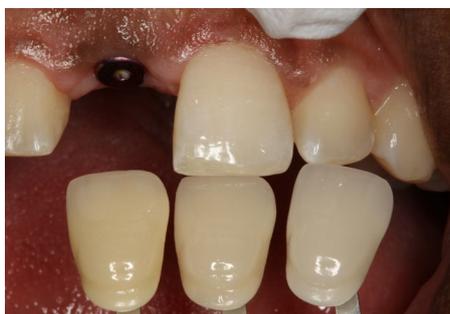
Figure 1: Anterior tooth aesthetics are critical. Colour data with shade tabs against various teeth will help guide the laboratory

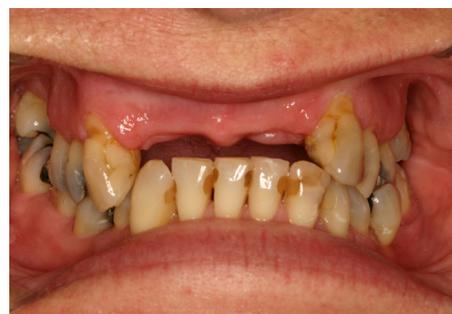
Figure 2: Minimal space is evident anteriorly for aesthetic functional reconstruction

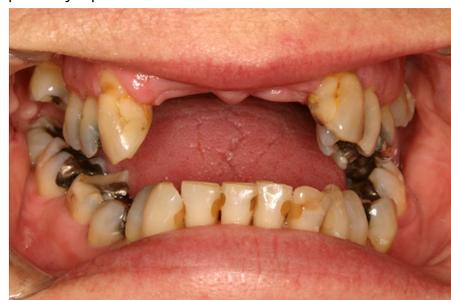
Figure 3: The irregularity of the occlusal plane is clearly illustrated when the patient's mouth is partially open

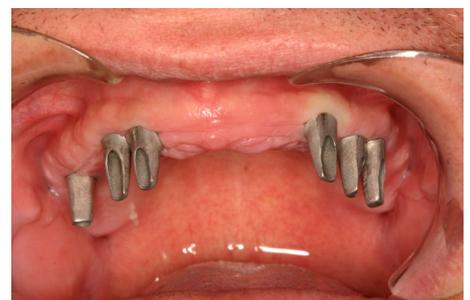
Figure 4: These implants show excellent tissue health around the abutments
